DWPC - Emergency Report
Field Operations Section

File American Cyanamide Region II Basin Des Plaines

SKETCH - IMPOUND PROFILE

SUBJECT: SPILL REPORT

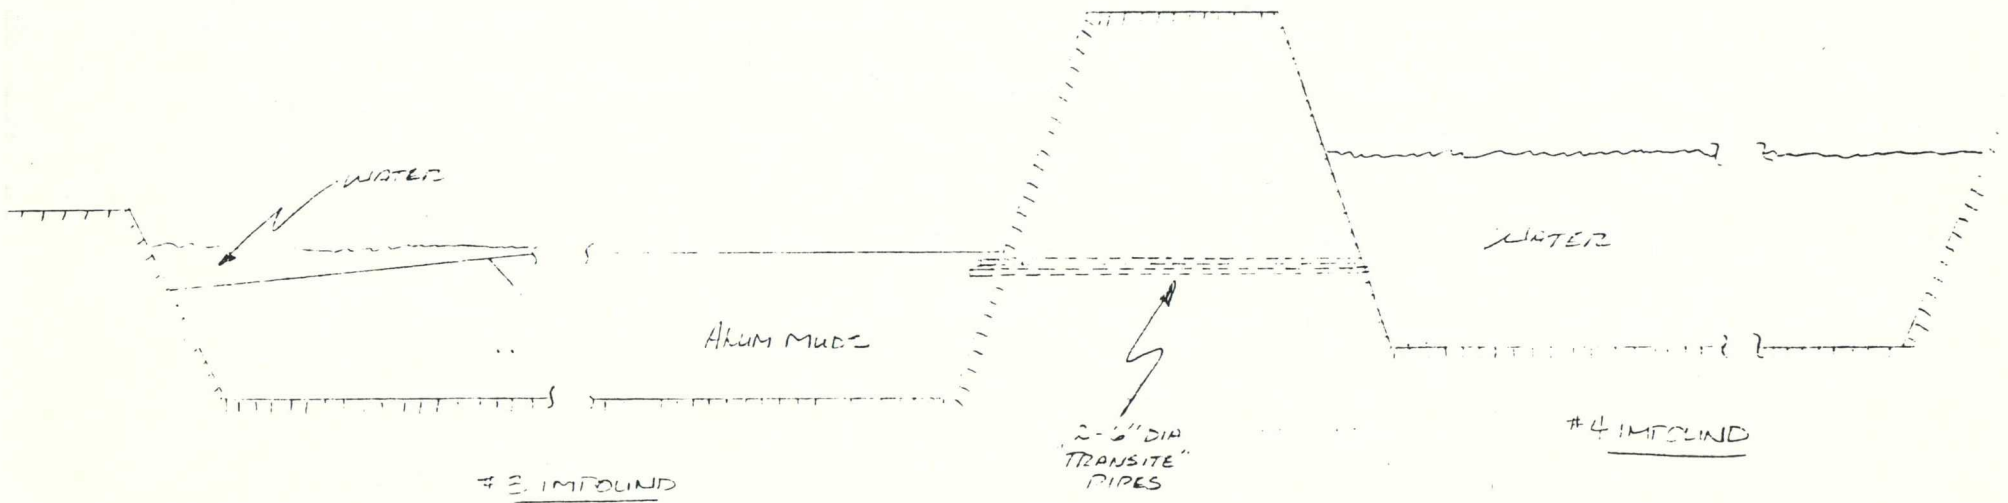
Action Taken & Comments On April 13, 1983 approximately 6:P.M., two six (6) inch transit pipe lines were ruptured (sketch attached). As a result of it impound #4 started draining in impound #3. Since impound #3 was nearly full with alum-mud, it rapidly filled and overflowed its dikes in several areas running into plant stream which flows into Sugar Creek tributary to Des Plaines River.

Transit pipes were temporarily sealed at the time and later on May 3, 1983 during follow-up visit was reported sealed permanently.

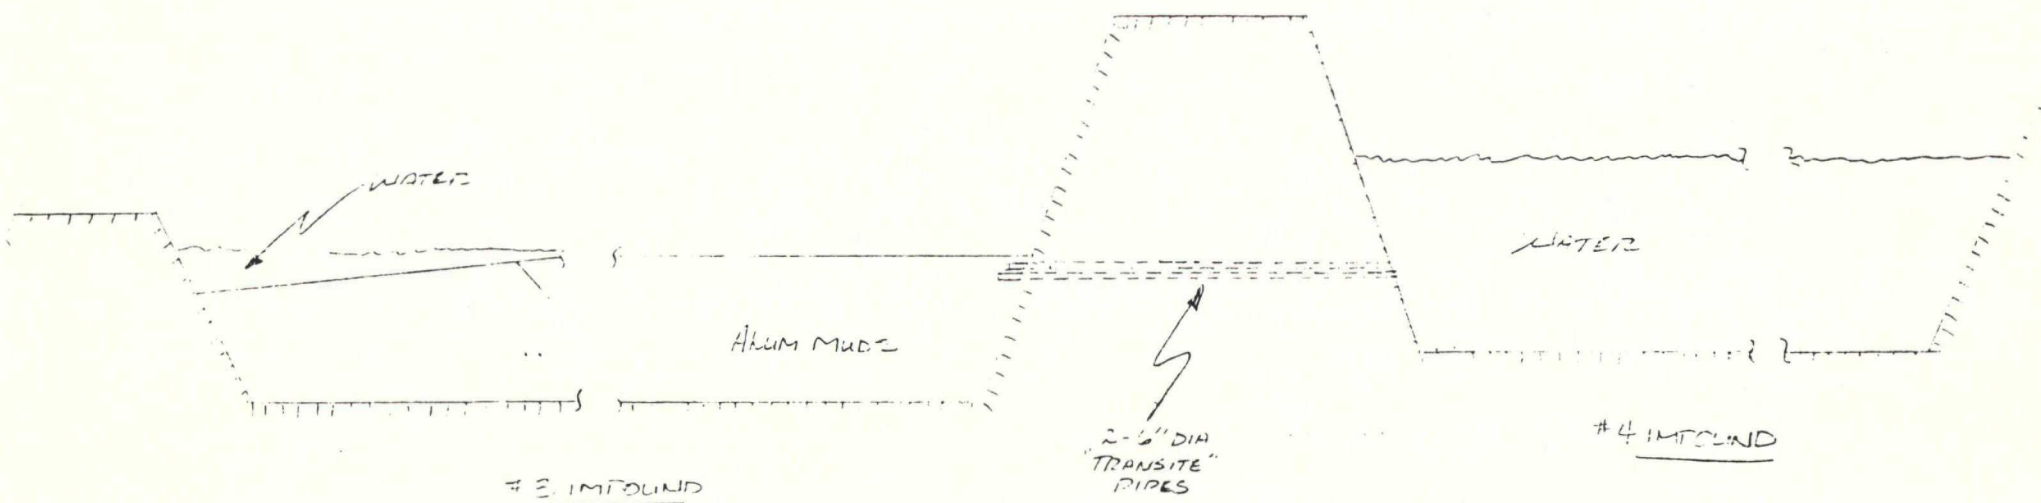
SKETCH - IMPOUND PROFILE

CAUSE: The cause of the spill was a result of two six(6) inch transite pipe lines extending through the dike wall separating #3 and #4 impounds. Present operating personnel were unaware of their existence. The lines were apparently not properly sealed off, when their use was discontinued 10 to 15 years earlier. The lines gave way on the evening of 13 April 1983 draining #4 impound into

#3 impound. Since #3 impound is nearly full with alum muds, it rapidly filled and overflowed its dike walls in several areas, running into the plant stream, which flows into Sugar Creek, which in turn flows into the Des Plaines River.

Upon arriving at about 8:45 P.M., I immediately inspected the impounds to determine the cause of the problem. At about 9:00 P.M. we discovered two (2)-six (6) inch lines, which were previously buried and unknown to operating personnel extending through the dike wall separating #3 and #4 impound (see attached sketch, Encl. (1), and flowing impound water from #4 impound to #3 impound. #3 Impound began to overflow again at about 9:30 P.M. due to the flow from #4 impound. In order to minimize the flooding damage, the overflow from #3 impound was directed into the plant stream, while repeated efforts were made to plug the two-six inch transite lines. By 11:00 P.M., one of the six inch lines was partially plugged; efforts continued all through the night to plug the other. At 11:15 P.M. a contractor, Leak Repairs, Inc., who specializes in plugging sealing lines, was called to help stop the flow. Their crew arrived at 1:00 A.M. and determined that they could not stop the flow. At 2:00 A.M., Advance Valve was called to see if they could possibly stop the flow, and subsequently determined that they could not help. In the meantime, plant personnel with the help of Mr. Alessio were continuing their efforts to plug the lines. An attempt at 3:00 A.M. to seal the lines from the waterside with a tarp failed.

On Monday 4/25/83, a diver was successful in sealing the two six inch transite lines with an inflatable plug. Afterwards, the lines were permanently sealed with a quick setting, non-shrinking cement.
